GM8428

2015-16 DURAMAX 6.6L DOWN PIPE 3-BOLT FLANGE

28 December, 2016

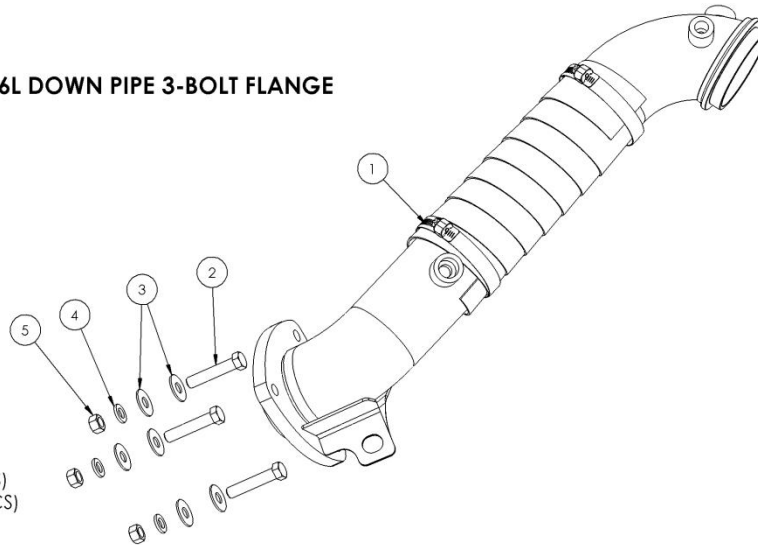
- 1. DOWN PIPE
- 2. 2" X 3/8" BOLT (3 PCS)
- 3. 3/8" FLAT WASHER (6 PCS)
- 4. 3/8" LOCK WASHER (3 PCS)
- 5. 3/8" NUT (3 PCS)

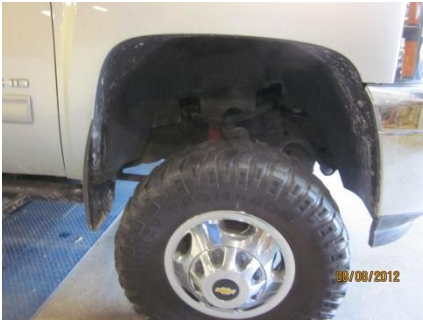
Figure 1

1. Remove the passenger-side inner fender.
See Figure 1.
Note: we also removed the Grille Assembly to prevent damage to it during the removal or installation of the down pipe.
2. The front pipe needs to be temporarily removed. Carefully disconnect all sensors and loosen the four flange nuts on the rearward part of the front pipe. The transmission cross-member will need to be temporarily dropped to remove the front pipe. Remember to support the transmission with a block or jack stand while doing the transmission cross-member removal.
See Figure 2.
3. Remove the hex bolt securing the down pipe to the exhaust manifold. Remove the sensor located just above the hex bolt. The 3 nuts connecting the front pipe to the down pipe can also be removed. Save the hex bolt, nuts and sensor for the installation.
See Figure 3.
